REGULATORY REFORM (FIRE SAFETY) ORDER 2005 (As amended) FIRE RISK ASSESSMENT

Tamar House

Responsible person (e.g. Employer) or person having control of the premises:	Plymouth Community Homes
Block Code:	BK07370A
Address of premises:	Tamar House, 2-180 James Street, Plymouth, PL1 4HJ
Person(s) consulted: (If applicable)	No-one consulted during this assessment.
Assessor:	Paul Bray GIFireE – Fire Safety Manager
Report validated by:	Nigel Hill GIFireE
Date of fire risk assessment:	12th May 2022 (Revised 10/02/2023 – Paul Bray)
Date of previous fire risk assessment:	18 th May 2021
Suggested date for review:	20th May 2023

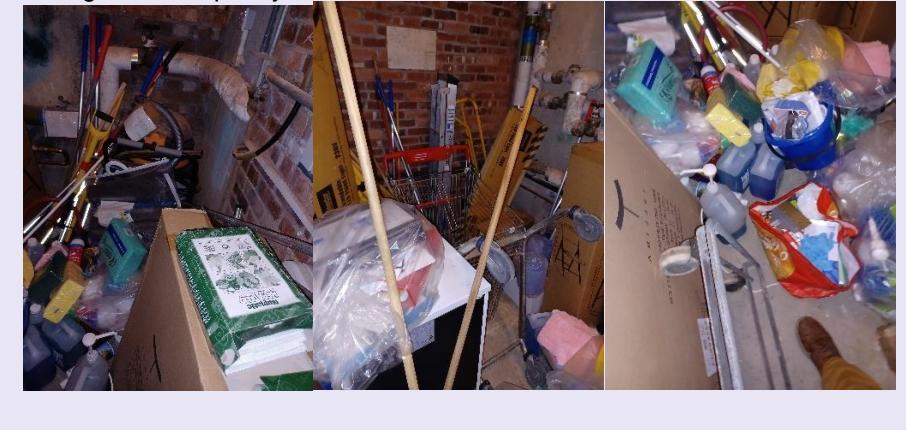
- The storeroom on the lower ground floor is very untidy, with cleaning equipment and other miscellaneous materials haphazardly left in the store. This area should be more carefully managed and kept tidy.

ltem	Report Ref.	Recommendation	Transferred to	Priority
1.	13.2.b	The storeroom on the lower ground floor is very untidy, with cleaning equipment and other miscellaneous materials haphazardly left in the store. This area should be more carefully managed and kept tidy.	Housing and environmental services	В
2.	17.2	Flats numbered 2, 120, 132 and 150 are leasehold properties and require an inspection to confirm if a working self-closing device is fitted.	Leasehold team	В
3.	17.2	Flat 178 has unauthorised doorbell, and knocker. These unauthorised fixings could compromise the fire performance of the door and should be removed and any holes repaired using suitable materials and techniques. All flat entrance doors are deemed to provide, at least, the minimum requirement of 30 minutes fire resistance.	Fire door team and Housing officer	В
