REGULATORY REFORM (FIRE SAFETY) ORDER 2005 (As amended) FIRE RISK ASSESSMENT

Tamar House

Responsible person (e.g. Employer) or person having control of the premises:	Plymouth Community Homes
Block Code:	BK07370A
Address of premises:	Tamar House, 2-180 James Street, Plymouth, PL1 4HJ
Person(s) consulted: (If applicable)	No-one consulted during this assessment.
Assessor:	Paul Bray GIFireE – Fire Safety Manager
Report validated by:	Nigel Hill GIFireE
Date of fire risk assessment:	12th May 2022 (Revised 10/02/2023 – Paul Bray)
Date of previous fire risk assessment:	18 th May 2021
Suggested date for review:	20th May 2023

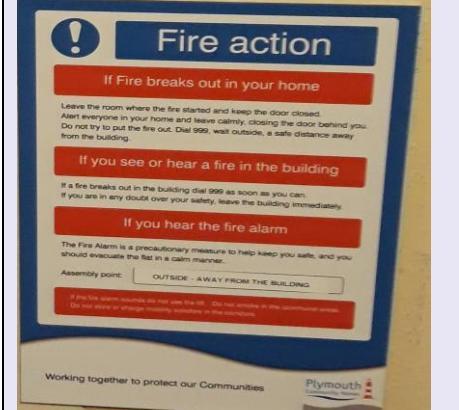
A 'Stay Put' strategy is in place and appropriate for this premises. There are fire action notices in place throughout the premises that reinforce this policy.
